# Property *Inspection Report*

Studio apartment

Initial Snagging Inspection

DMI-SAMPLE

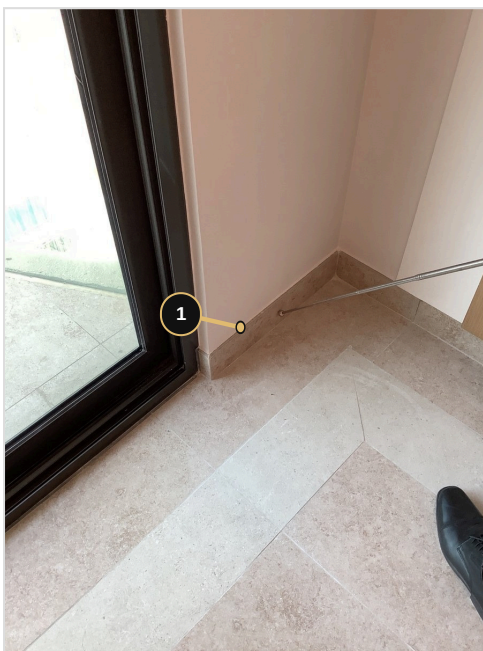
REF LIV-P01

- 1 Wall panel is hollow - to be re-fixed

| REF | AREA | REQUIRED REPAIR |
|---|---|---|
| LIV-P01-A01 | Living Room | Wall panel is hollow - to be re-fixed |

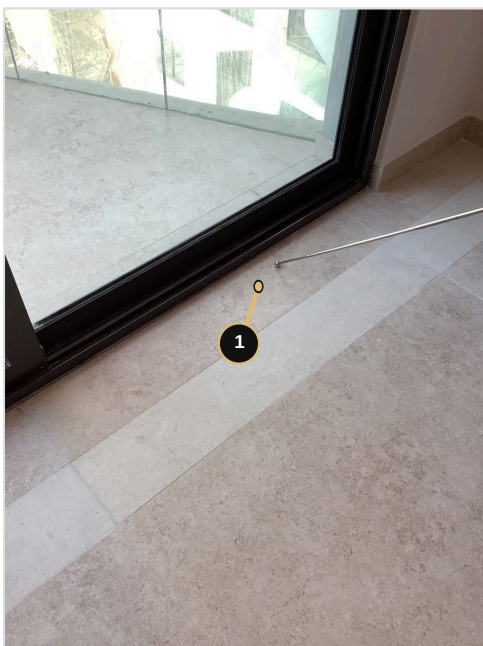
REF LIV-P02

- 1 Floor tile is hollow - to be replaced

| REF | AREA | REQUIRED REPAIR |
|---|---|---|
| LIV-P02-A01 | Living Room | Floor tile is hollow - to be replaced |

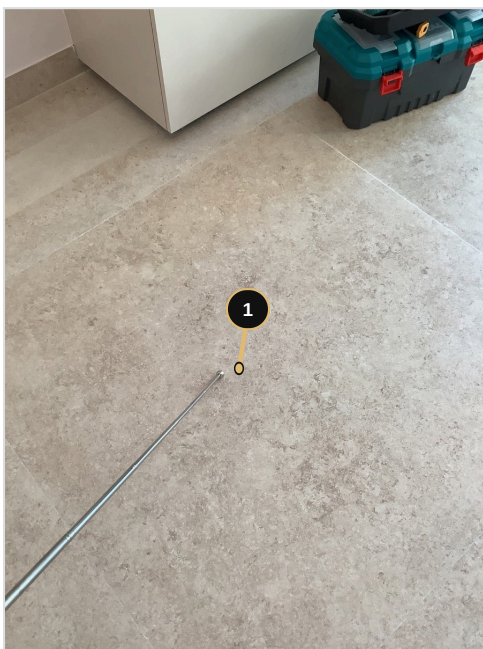
REF LIV-P03

- 1 Floor tile is hollow - to be replaced

| REF | AREA | REQUIRED REPAIR |
|---|---|---|
| LIV-P03-A01 | Living Room | Floor tile is hollow - to be replaced |

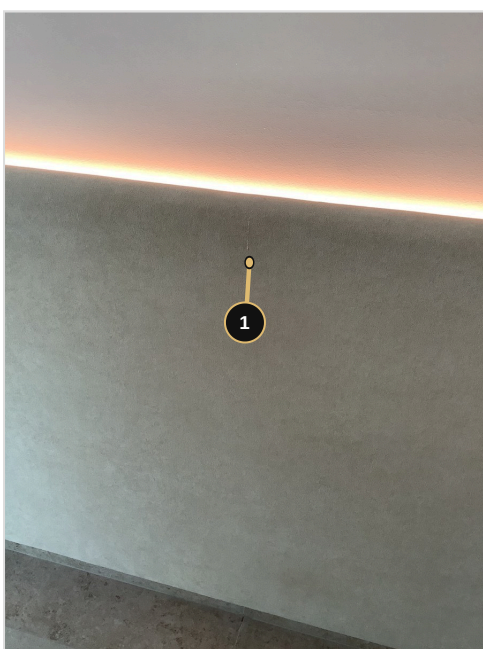
REF LIV-P04

- 1 Surface requires cleaning

| REF | AREA | REQUIRED REPAIR |
|---|---|---|
| LIV-P04-A01 | Living Room | Surface requires cleaning |

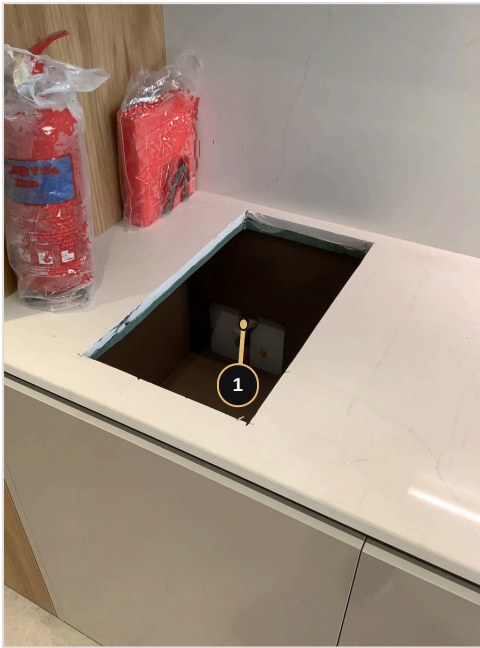
REF KIT-P01

- 1 Cooker not supplied

| REF | AREA | REQUIRED REPAIR |
|---|---|---|
| KIT-P01-A01 | Kitchen | Cooker not supplied |

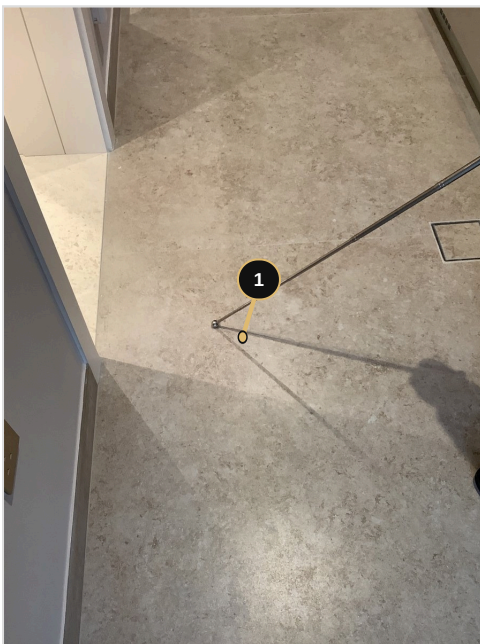
REF KIT-P02

- 1 Floor tile is hollow - to be replaced

| REF | AREA | REQUIRED REPAIR |
|---|---|---|
| KIT-P02-A01 | Kitchen | Floor tile is hollow - to be replaced |

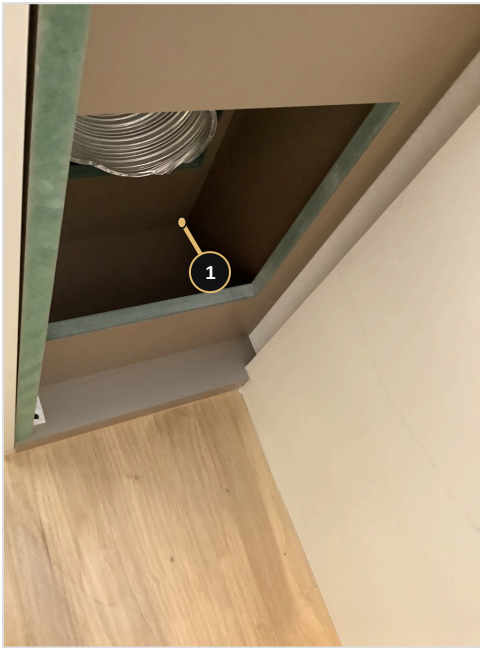
REF KIT-P03

- 1 Cooker hood (steam collector) not supplied

| REF | AREA | REQUIRED REPAIR |
|---|---|---|
| KIT-P03-A01 | Kitchen | Cooker hood (steam collector) not supplied |

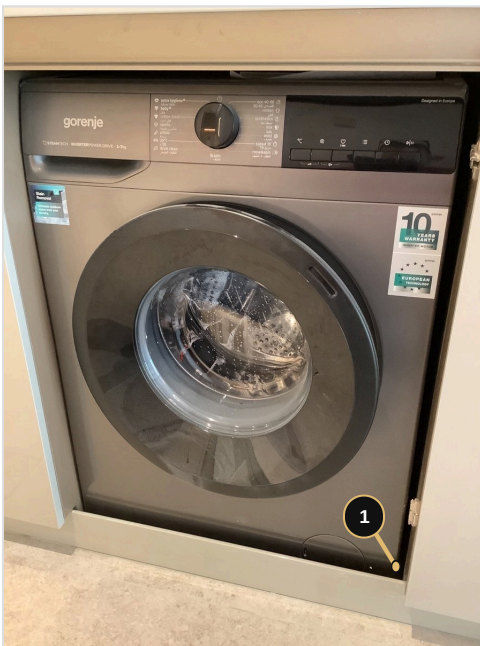
REF KIT-P04

- 1 Washing machine cabinet door not supplied

| REF | AREA | REQUIRED REPAIR |
|---|---|---|
| KIT-P04-A01 | Kitchen | Washing machine cabinet door not supplied |

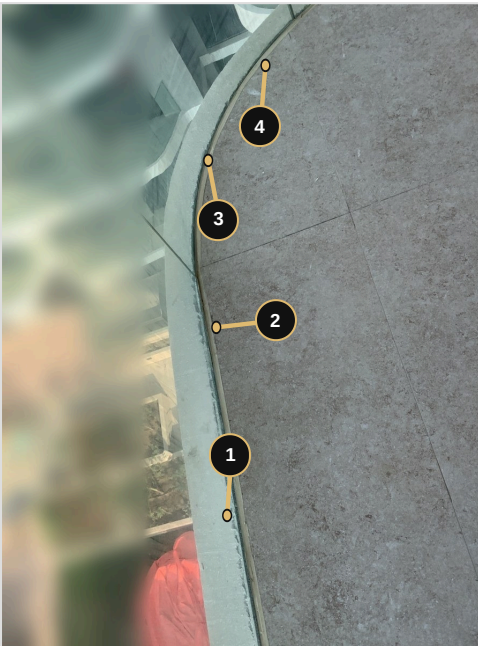
REF BAL-P01

- 1 Edge finishing to be corrected
- 2 Edge finishing to be corrected
- 3 Edge finishing to be corrected
- 4 Edge finishing to be corrected

| REF | AREA | REQUIRED REPAIR |
|---|---|---|
| BAL-P01-A01 | Balcony | Edge finishing to be corrected |
| BAL-P01-A02 | Balcony | Edge finishing to be corrected |
| BAL-P01-A03 | Balcony | Edge finishing to be corrected |
| BAL-P01-A04 | Balcony | Edge finishing to be corrected |

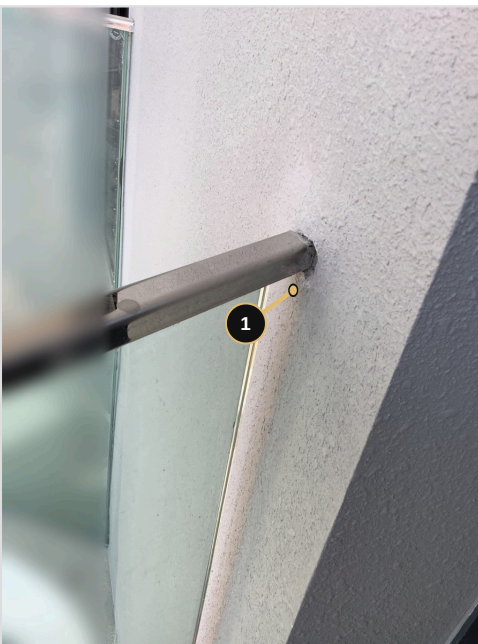
REF BAL-P02

- 1 Re-seal handrail and wall junction

| REF | AREA | REQUIRED REPAIR |
|---|---|---|
| BAL-P02-A01 | Balcony | Re-seal handrail and wall junction |

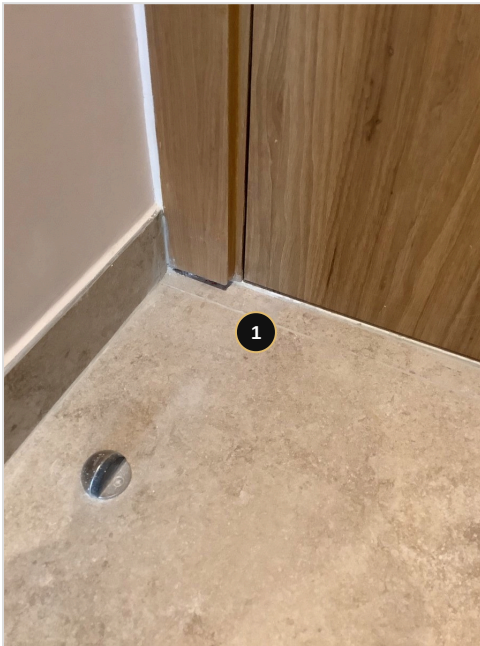
REF ENT-P01

- 1 Entrance door - re-seal (left side)

| REF | AREA | REQUIRED REPAIR |
|---|---|---|
| ENT-P01-A01 | Entrance | Entrance door - re-seal (left side) |

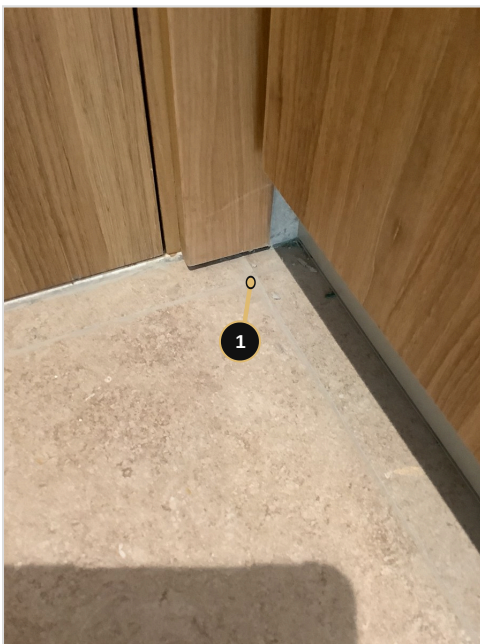
REF ENT-P02

- 1 Entrance door - re-seal (right side)

| REF | AREA | REQUIRED REPAIR |
|---|---|---|
| ENT-P02-A01 | Entrance | Entrance door - re-seal (right side) |
